**Playing Surface Impact Test Report
Artificial Playing Surface**

Home Depot Center
Football - Soccer Stadium
Carson, CA

Test Date: December 7, 2011

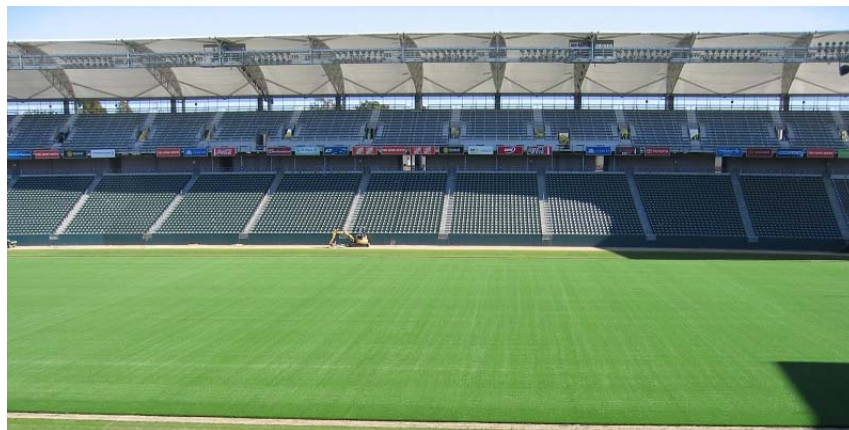
Field Average G max	108.5
Field Max. Avg. G max	116.9
Site maximum G max	119.6
Avg. Strand Length	52.4mm
Avg. Infill Depths	30.0mm

Test results reported herein reflect the conditions of the tested field at the time of testing and at the temperature(s) reported under the stated test conditions, all points met the requirement of <200 G max when tested in accordance with ASTM F1936
